# Strengthening and Restoration of Heritage Buildings

*Thiru K.P.Mohandas*

*Asst.Superintending Archaeologist,Archaeological survey of India, Chennai Circle, Chennai*

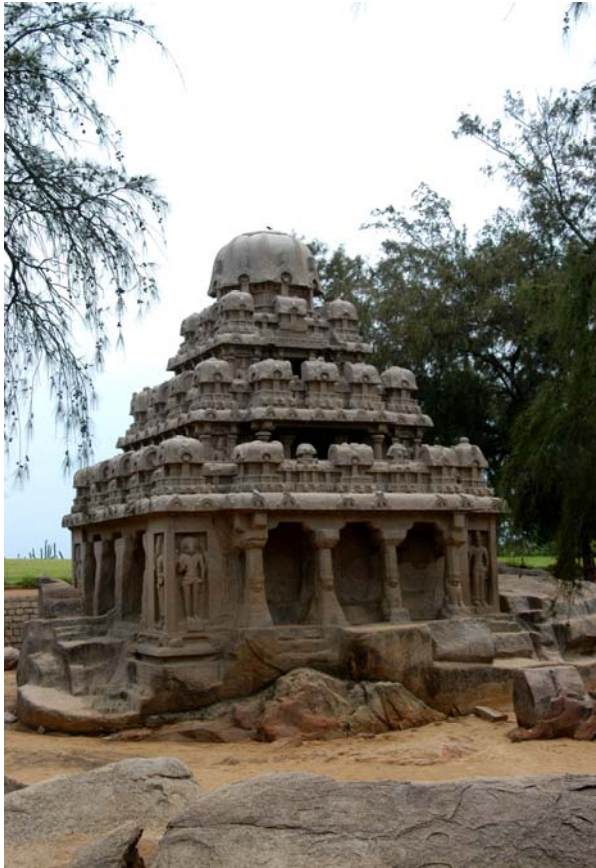
Monolithic temples

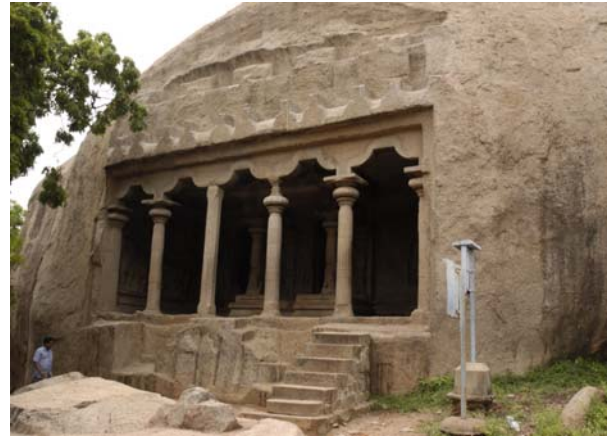
Cave temples

*Created during the reign of  
Narasimhavarman, Pallava  
king and by successive kings in the  
late 7th –early 8th Century*

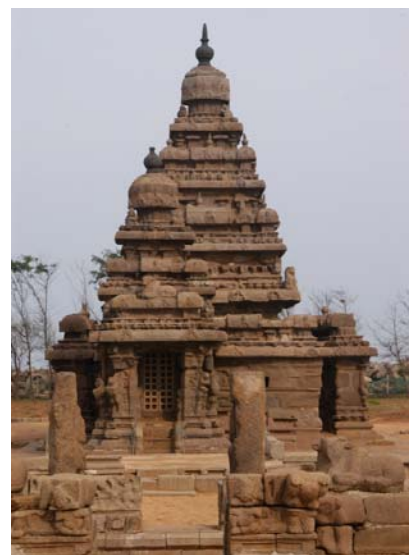
Structural temples

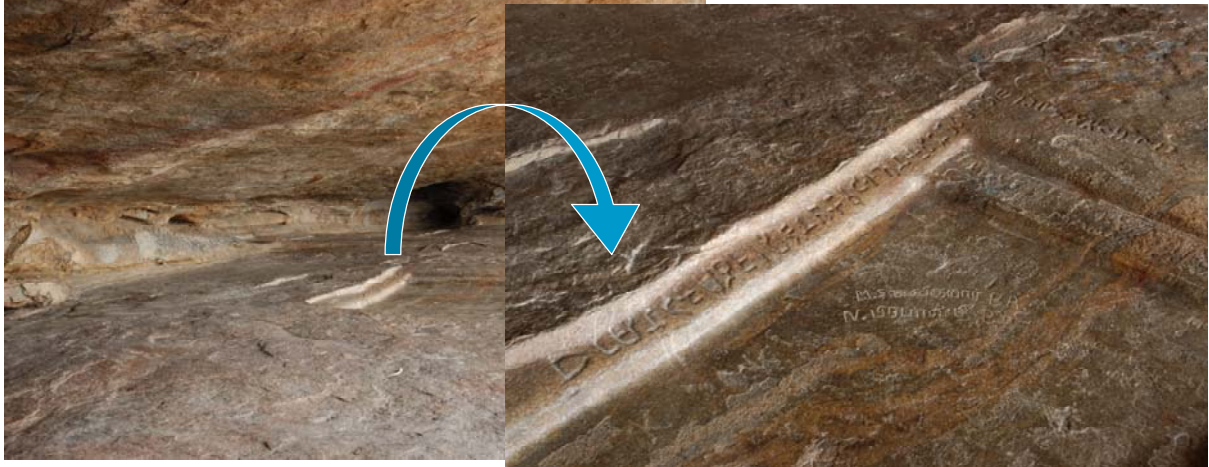
*Rock shelters were habited by Jain ascetics right from 2nd century BC. The beds which they used contain the Brahmi inscriptions recoding the name of the person who donated the beds. The writings are the earliest forms of Indian Scripts*

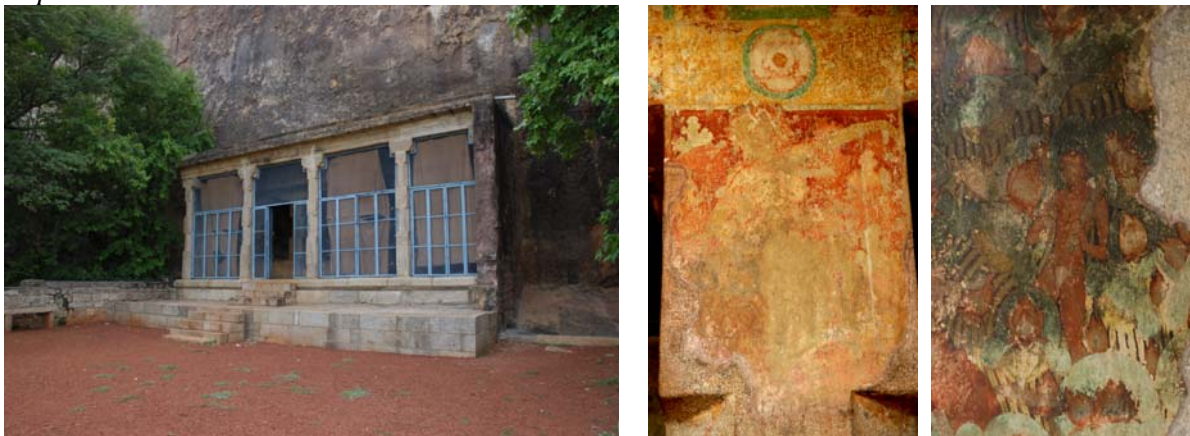
*The rock cut Jaina temple has some of the exquisite murals.*

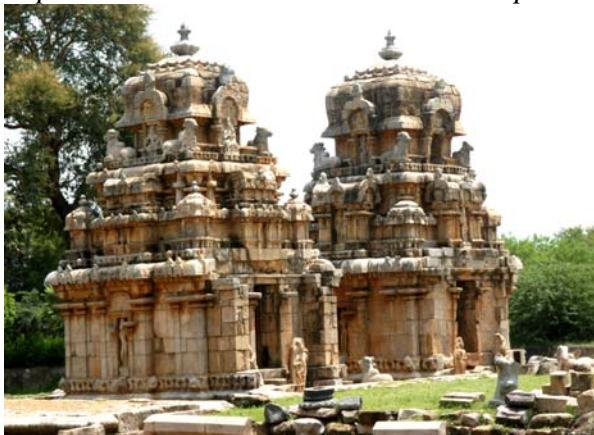
*Kodumbalur was the capital of Irrukkuvels, who lent support to the Cholas. It was also a centre of intense Saiva cults. The Muvar Koil, built by Bhuti Vikramakesari and his two queens around AD 850, were gems. Elegant, proportionate and has many exquisite and expressive sculptures*

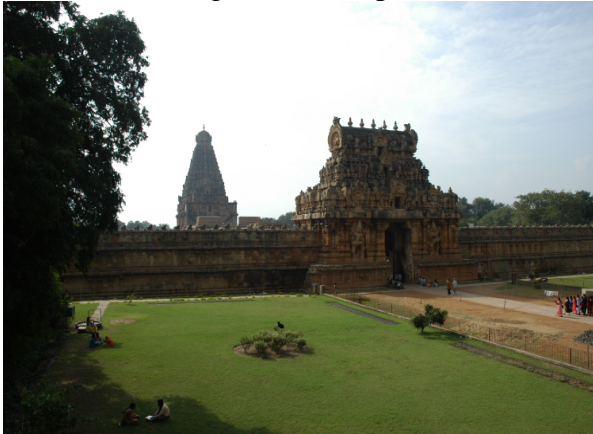
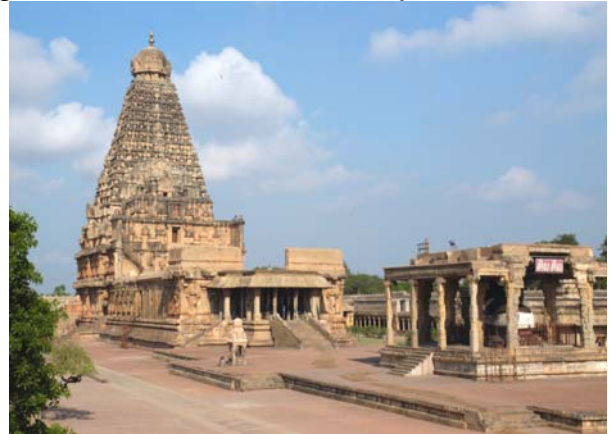
*The temple par excellence. Built around 1010 AD, Vast in concept, perfect in execution, extraordinary in administration. Rajaraja, the great Chola monarch not only built a temple which is at least 40 times bigger than the earlier temple, he created an extraordinary institution to manage it.*

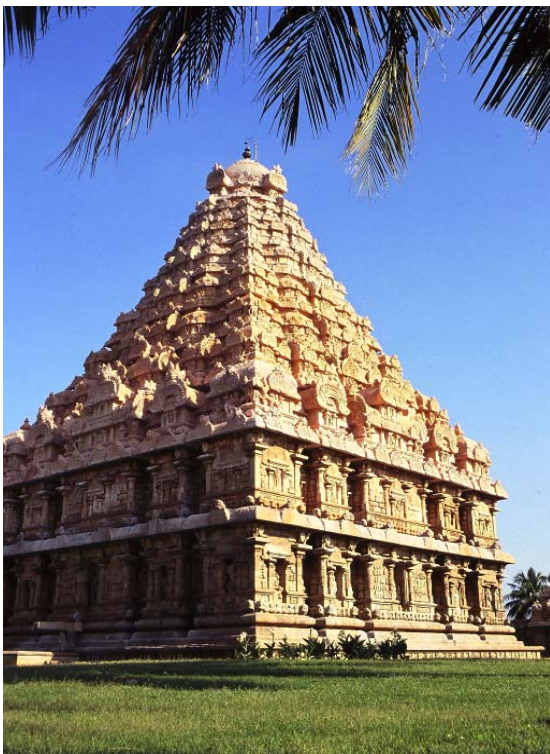
*The Brihadisvara, Gangaikondacholapuram*

*Rajendra (1014-1042) son of Rajaraja had victorious campaigns upto the banks of Ganges. He also led an equally brilliant naval expeditions to the far east.*

*True to his grand achievements he created a new capital – Gangaikondacholapuram- with an another magnificent temple. It said the Chola architects corrected some of the flaws in the design of earlier Brihadisvara at Tanjavur*

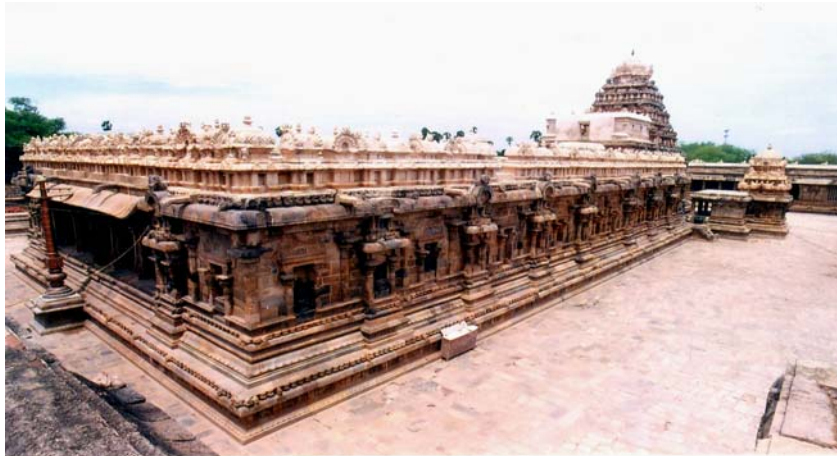
*The Airavatesvara, Darasuram*

*Built by Rajadhiraja (1146-1173). Smaller but highly ornate. Contains friezes depicting events from the lives of Saiva nayanars*

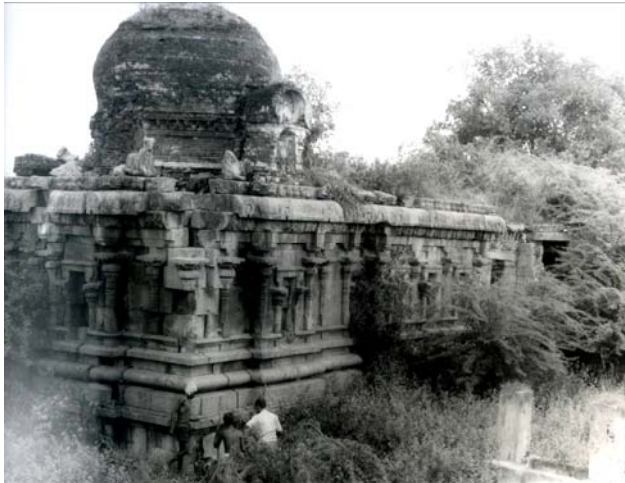
Patalesvara temple,  
Brahmadesam, Villupuram District  
c. 11th century AD

Once supported by extensive grants of the Cholas, formed a complex of a Vedic University with hostel and Medicare for inmates

Till ASI took over, negligence caused extensive vegetation growth

Vegetation caused dislodgement of architectural members from their original position

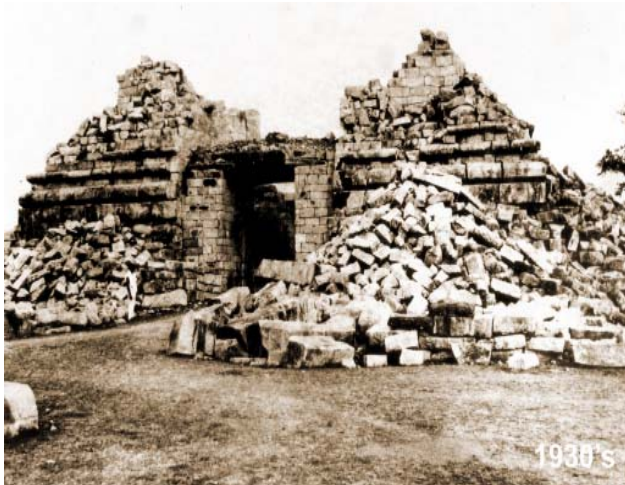
Brihadisvara temple  
Gangaikondacholapuram  
District Perambalur,  
11th Century AD,

This gateway was standing in full until a British officer in 1836 ordered blasting of the gateway and the compound for fetching stone for the construction of a weir across Kollidam (Coleroon).

Public outcry stopped further blasting. But the damage was done.

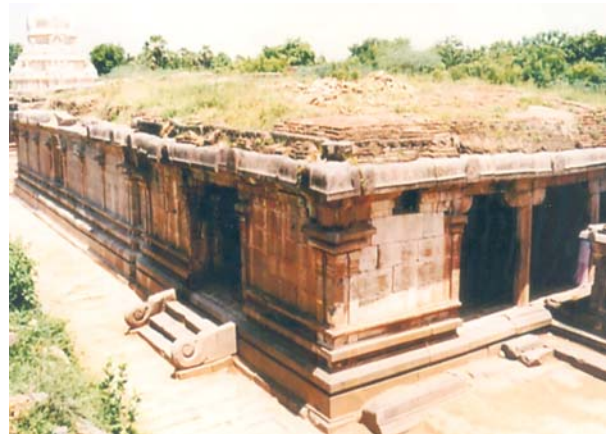
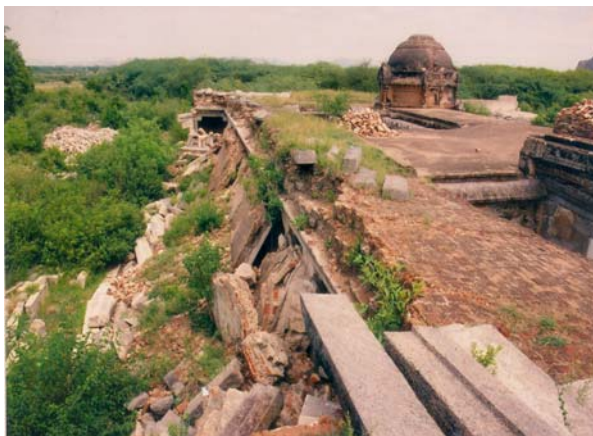
Brahmapurisvara temple,  
Brahmadesam  
District Villupuram

11th Century AD,  
Overloading of roof with layers of bricks  
Overloading of the roof of the cloister caused the collapse one of the bays. The rank vegetation grown on the wall added to the problem.

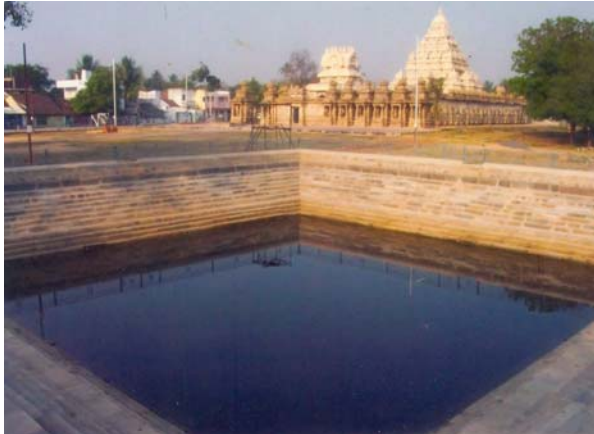
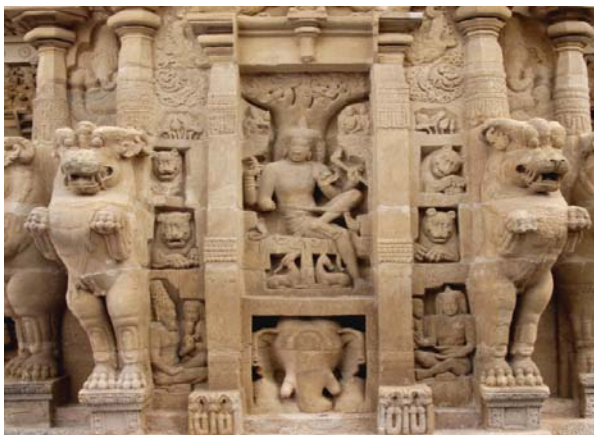
*Almost all the south Indian temples and temple complexes had massive temple tanks. These tanks served as a source of water and a tank to receive the run off water. This synergy solved the problems of drainage.*

*Of late, the original drainage of almost all temples are altered within the complex and due to raising levels of the roads outside due to layers of resurfacing. This kills the tanks.*

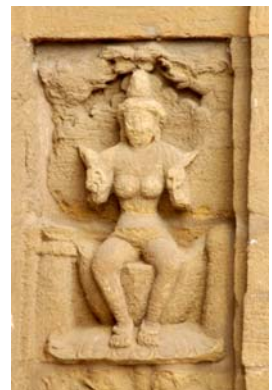
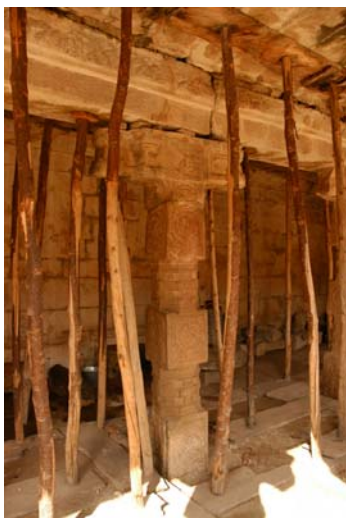
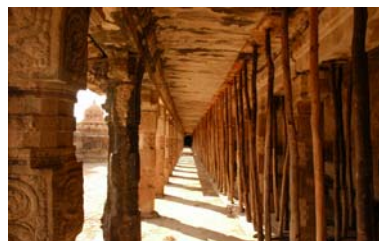
Kailasanatha temple,  
Kanchipuram  
8th century AD

Being the first major structural temple, the architects used a highly soft sandstone. The stone could not withstand the vagaries of nature in the past 1300 years resulting in weathering of features.

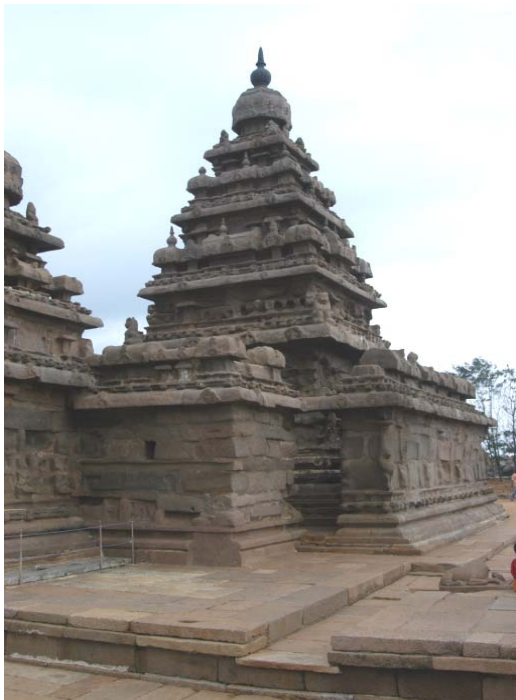
Shore temple, Mahabalipuram

- The proximity to sea has caused immense damage to the structure.
- The features are rounded
- The joints have widened
- But the selection of the site by constructing the temple on a bed jutting into the sea had saved the structure from collapsing even though the waves used to lash it until few decades ago

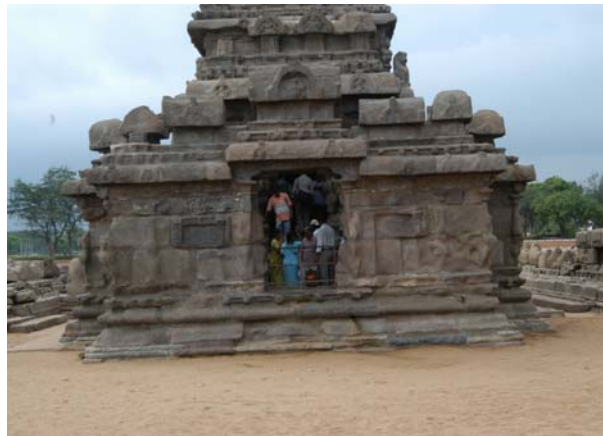
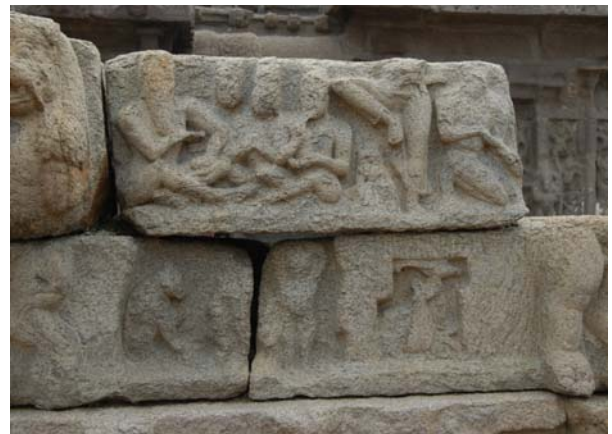
Shore temple, Mahabalipuram

The features are rounded  
The joints have widened

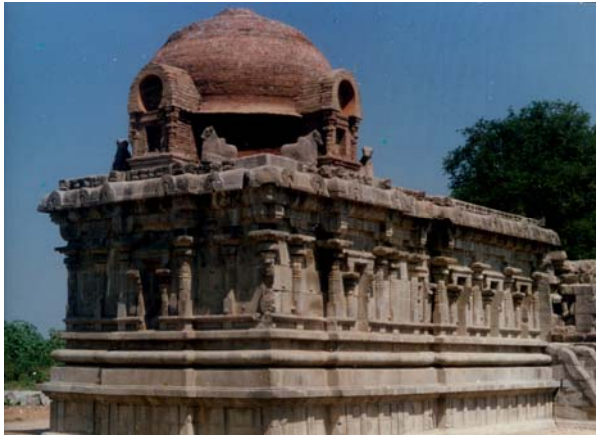
The monument was conserved after clearing the vegetation. Since the brickwork is supported by the inner veneer wall of stones, it was easy to conserve. The outer veneer was dismantled after documentation and reconstructed.

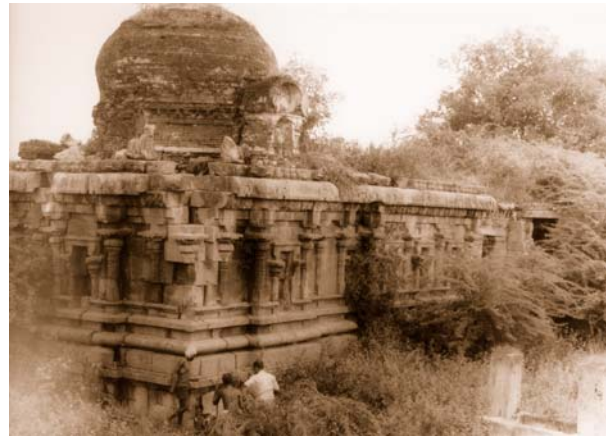
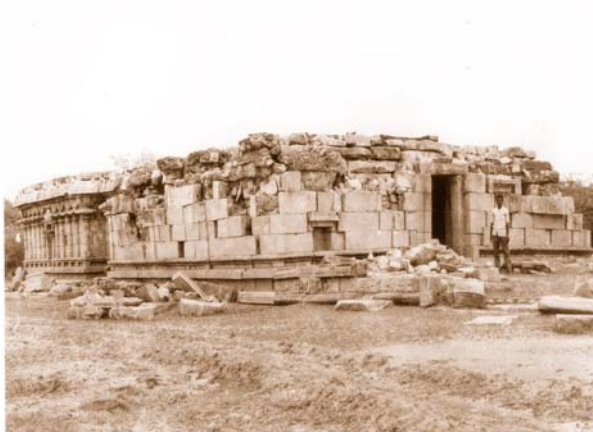
### Patalesvara temple, Brahmadeesam

The monument was fully covered with vegetation. Several architectural members were dislodged.

This is common problem of this region – neglect for a long time. Majority of the temples in this region are located in close proximity to a tank. Therefore, when reconstructed, adequate strength to the foundation need to be provided.

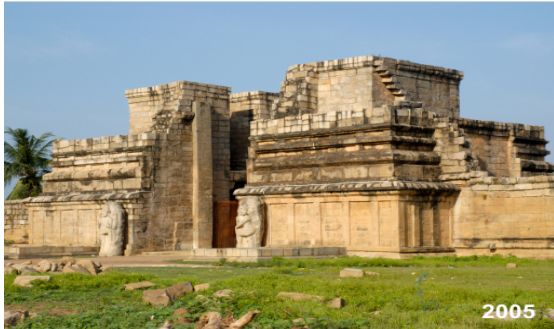
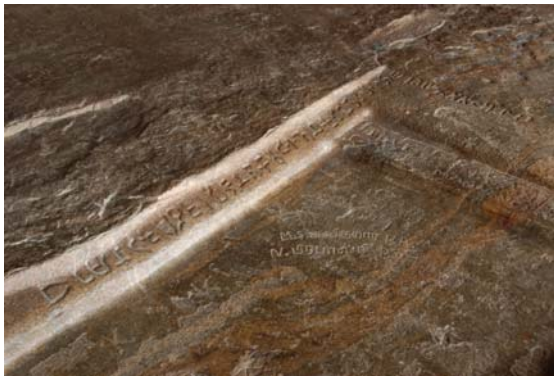
Brihadisvara,  
Gangaikondacholapuram

Most of the architectural members were available in the heap. Their original position in the structure was worked out. Those do not integrate was kept aside. The reconstruction was done to the height for which evidence was seen at that time

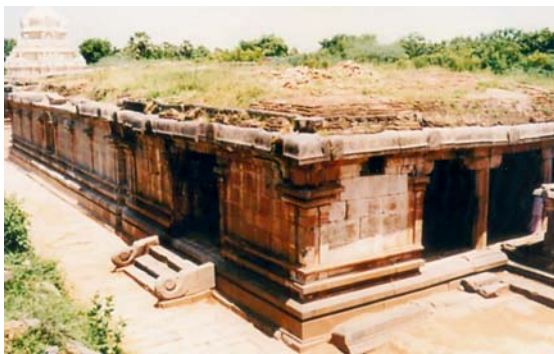
A massive grill was now put up to prevent entry of visitors. Still some enter through gaps

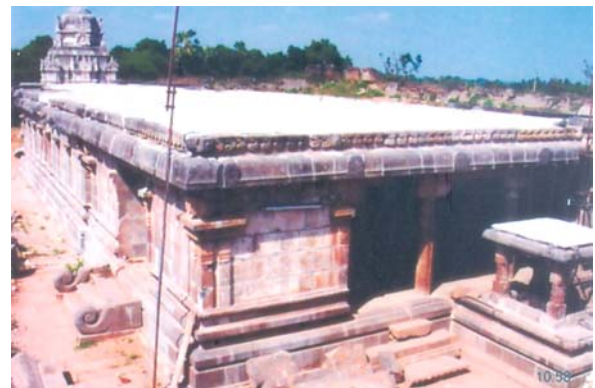
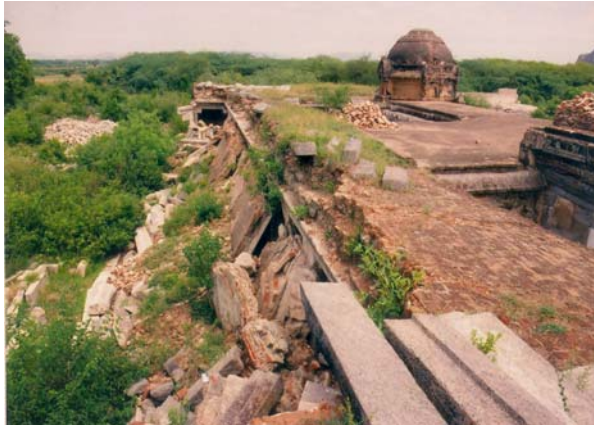
Apatshayesvara temple, Sendamangalam,  
V'Puram Dt

The monument was protected in 2000. Entire temple was in a dilapidated condition.

Sustained conservation measures since then has preserved the monument.

Watertightening of the roof of main temple was redone after removing the worn out layers.

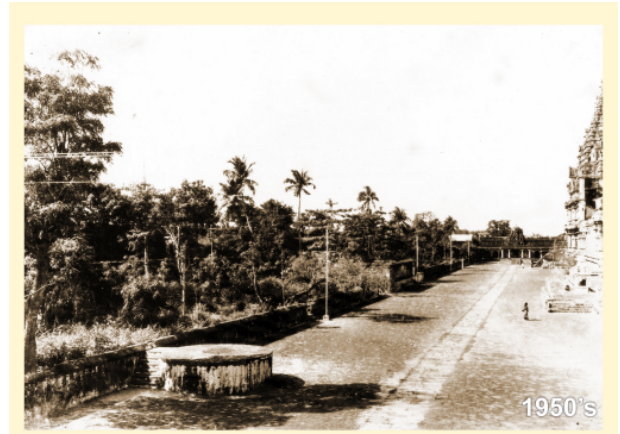
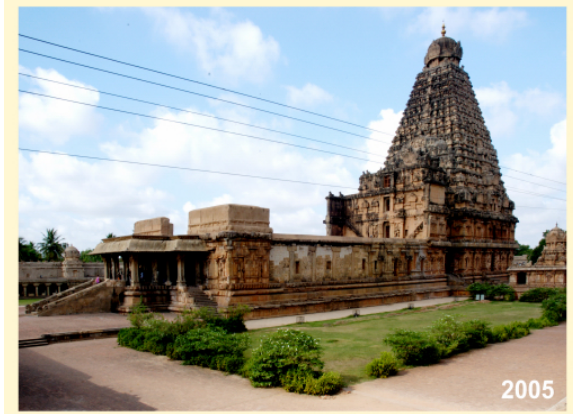
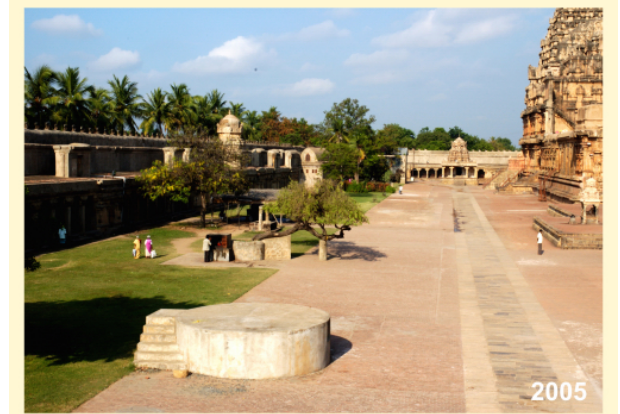
Brihadisvara, Tanjavur – removal of accumulated earth and bringing the original working level back into use

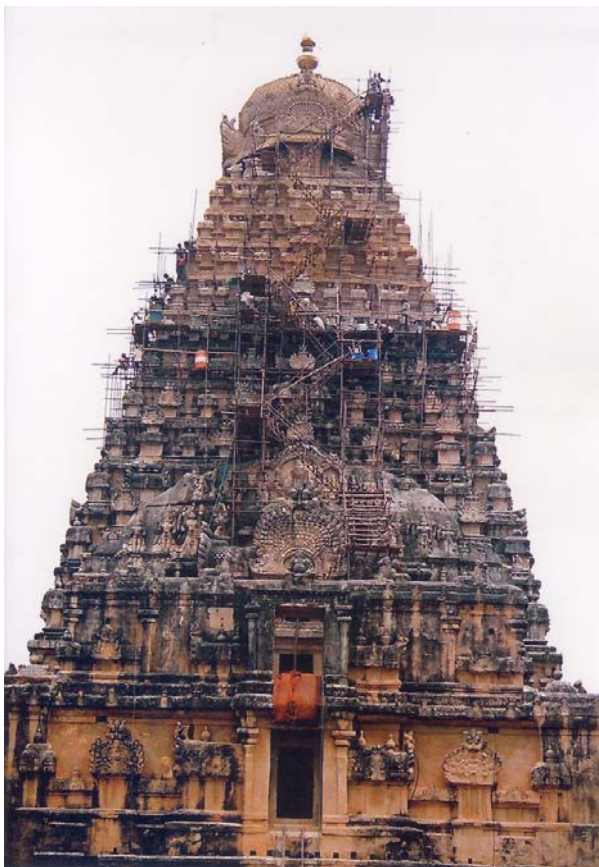
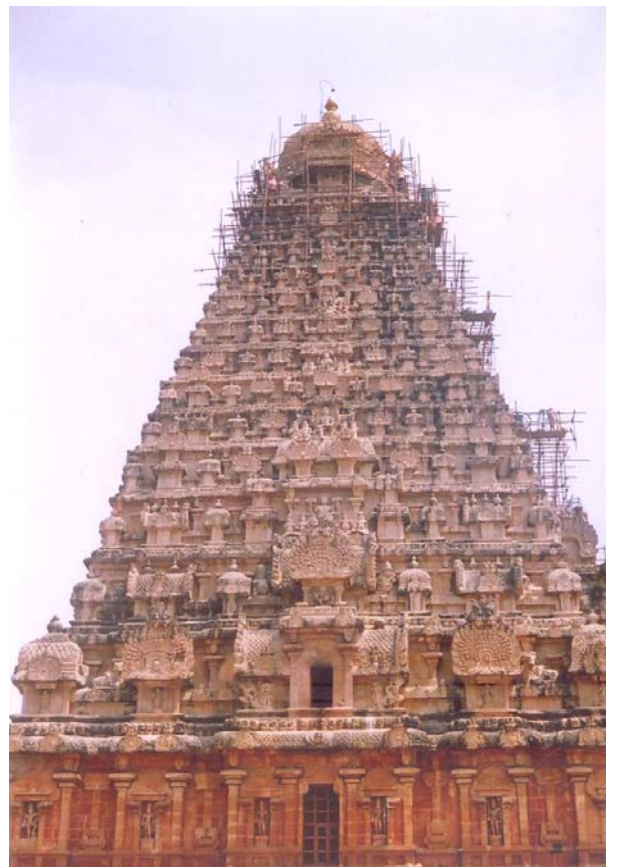
Brihadisvara temple, Tanjavur – Removal of accretional garden

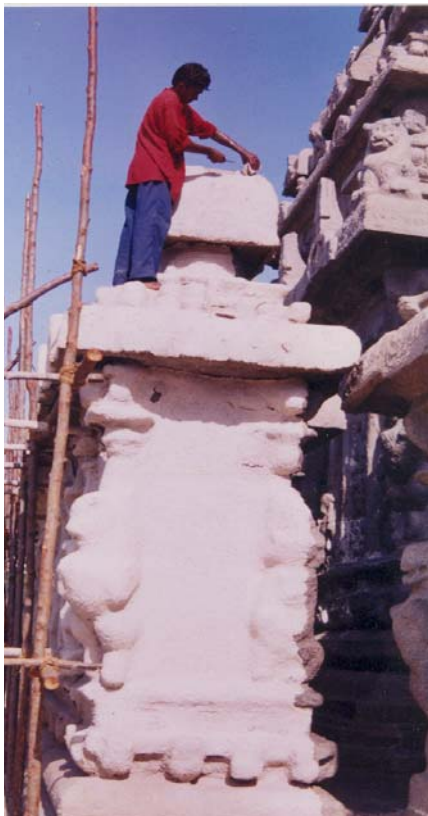
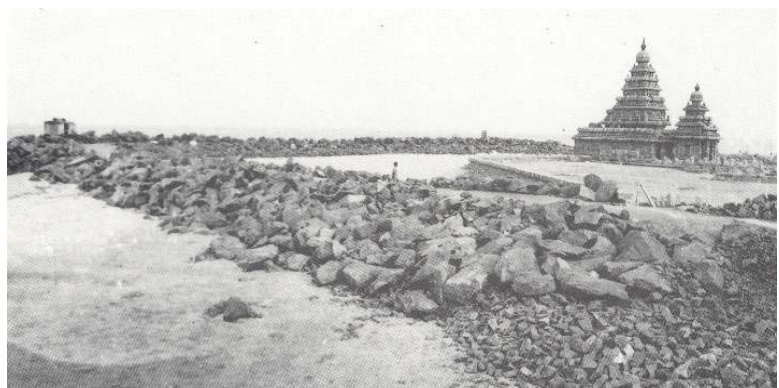
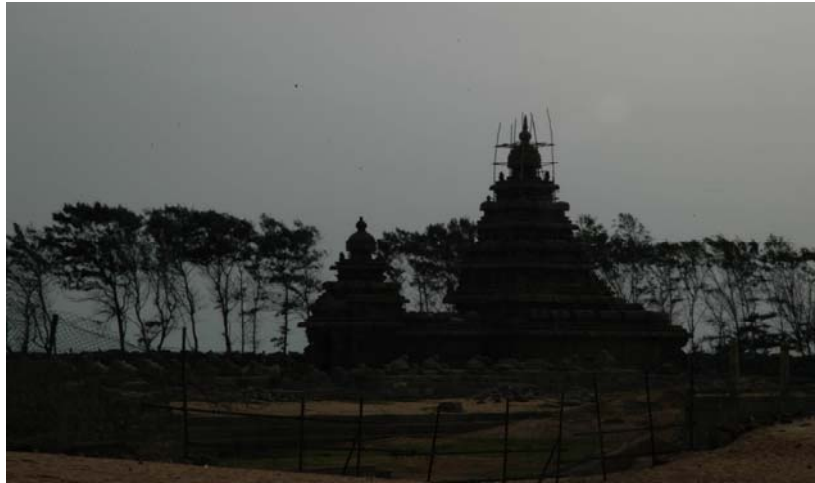
*Climatic Problems*  
Shore temple, Mahabalipuram  
8th century AD  
World Heritage Site

Application of paper pulp to remove salts  
Construction of a groyne wall

- The groyne wall built around the temple played its role in saving the temple during the 2004 Tsunami.

- The problems of this site is being tackled continuously for over a century.
- The opened up joints are being pointed matching with the original
- A massive groyne wall of stone was constructed to push the sea away from the monument
- Periodical removal of salts by paper pulp method is being undertaken
- Plantation are grown to arrest the speed of the wind
